Manhole Inspection Summary

Manhole # S51O__004MH

Insp Date: **7/28/09 10:52 AM**

Location Address: **1202 S. POTOMAC ST**

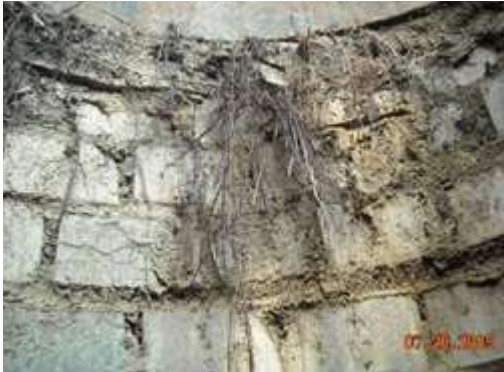
Defect 2

Condition: ☐ Sound ☐ Cracked ☒ **Root Intrusion** ☐ Loose Brick ☐ Deteriorated

ROOT INTRUSION @ CHIMNEY/FRAME JOINT

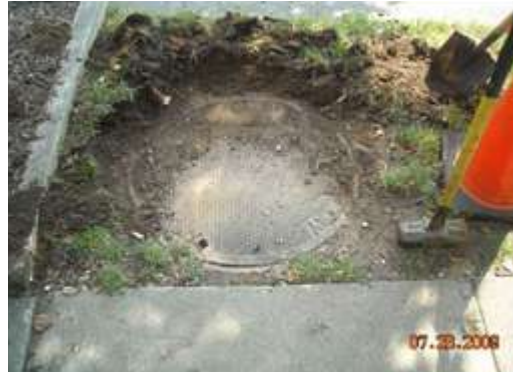
Defect 1

Diameter: **24** (in.) Length: **0** (in.) Dist A/B Grade: **-2** (in.)

FRAME BELOW GRADE

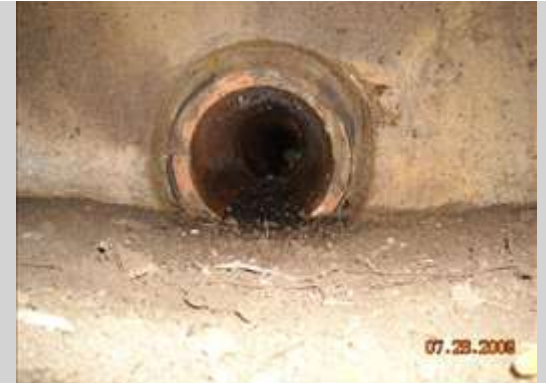
12 O'Clock Outflow

8 in. Circular Gravity Sewer
Pipe Out @ 12 O'Clock

Deposits: ☐ None ☐ Mud ☐ Sludge ☒ **Debris** ☐ Grease

Silt Depth: **0** (in.) Deposits Extent: **Light**
